CONTINUING ELIGIBILITY INSPECTION (CEI) REPORT
FOR FLOOD CONTROL WORKS
Honolulu Engineer District
CEPOH-EC-T

1. Project Name: Wailoa FCP
2. Date of Inspection: October 17, 2005
3. Inspection Personnel:

The project provides for approximately 4,080 feet long channel, three diversion channels totaling 1,800 feet in length, and eight diversion levees totaling 8,073 feet in length. The channel invert had minimal flow during the inspection.

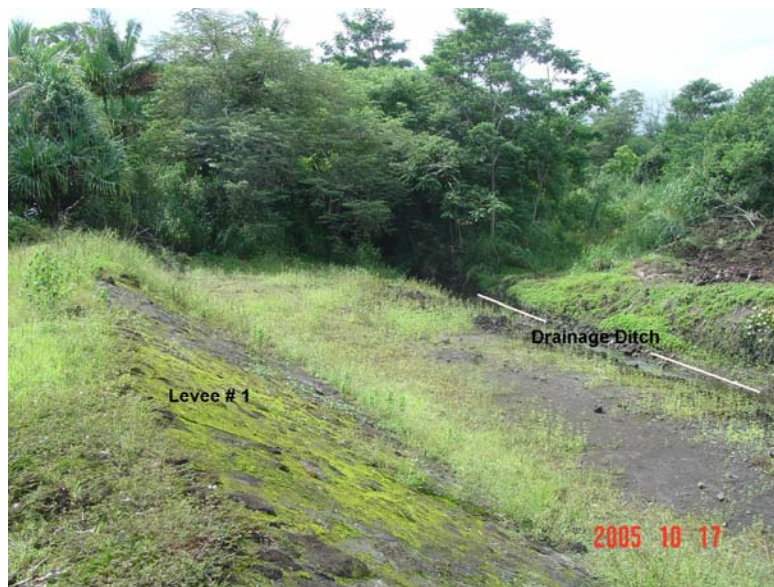
- a. Sta. 90+00, Right Bank (RB) Looking Upstream at Levee #1, continue to remove vegetation.

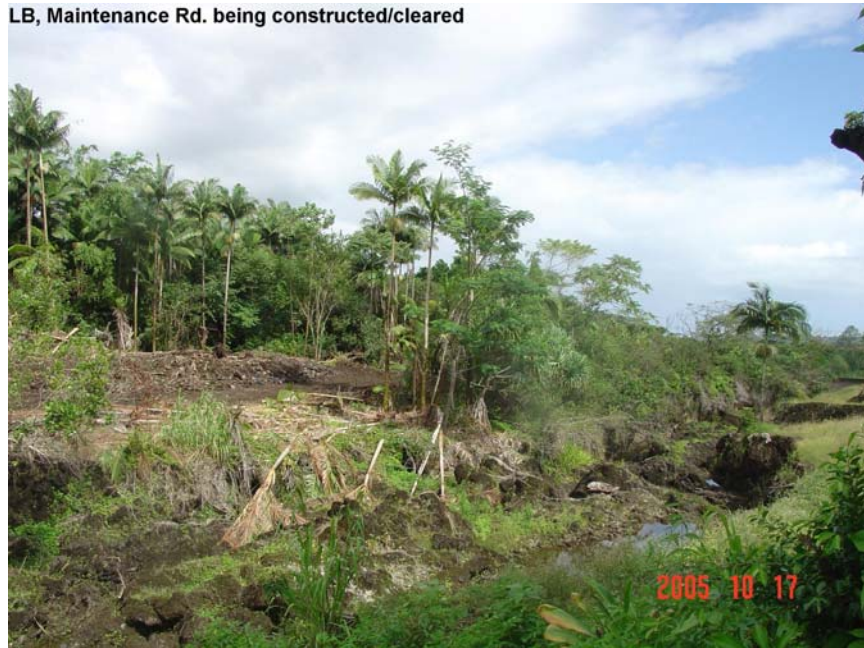
LB, Maintenance Rd. being constructed/cleared

- b. Sta. 89+00, LB, maintenance access road being constructed.

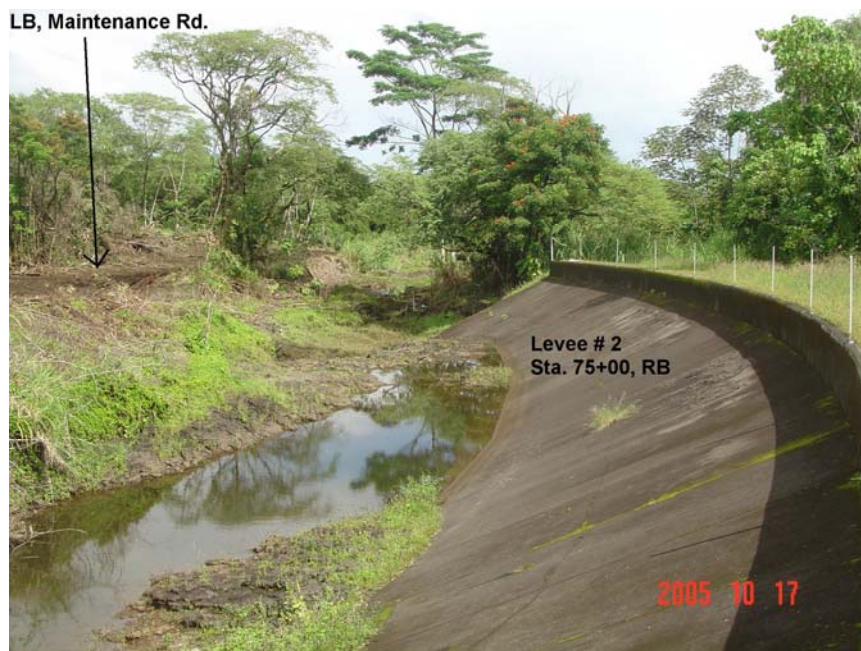
LB, Maintenance Rd.

- c. Sta. 75+00, Right Bank (RB) Looking Downstream at Levee #2, continue to herbicide vegetation growing in weep holes and construction joints.

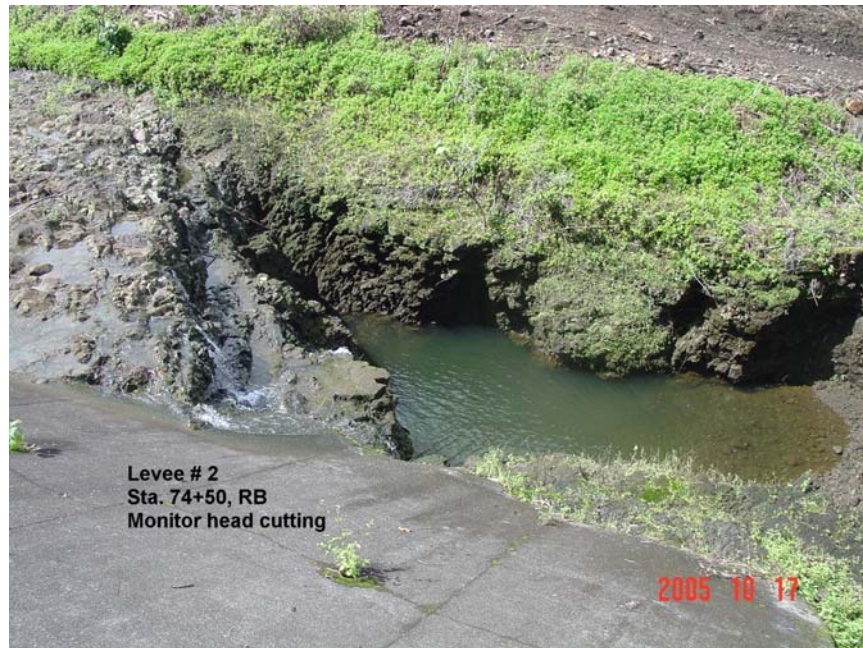
d. Sta. 74+50, RB, monitor head-cutting adjacent the toe of the sideslope.

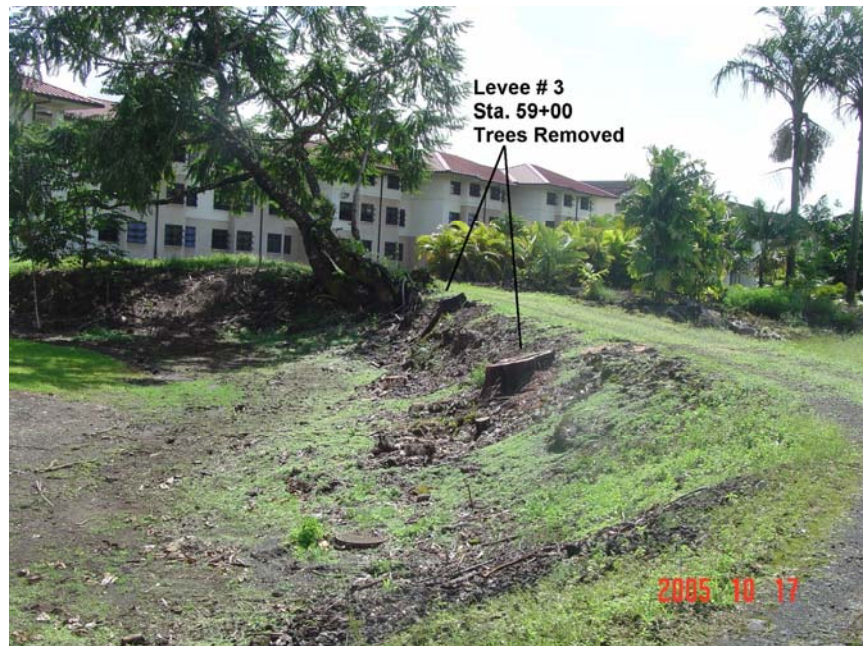
e. Sta. 59+00, Right Bank (RB) at Levee #3, trees removed from sideslope.

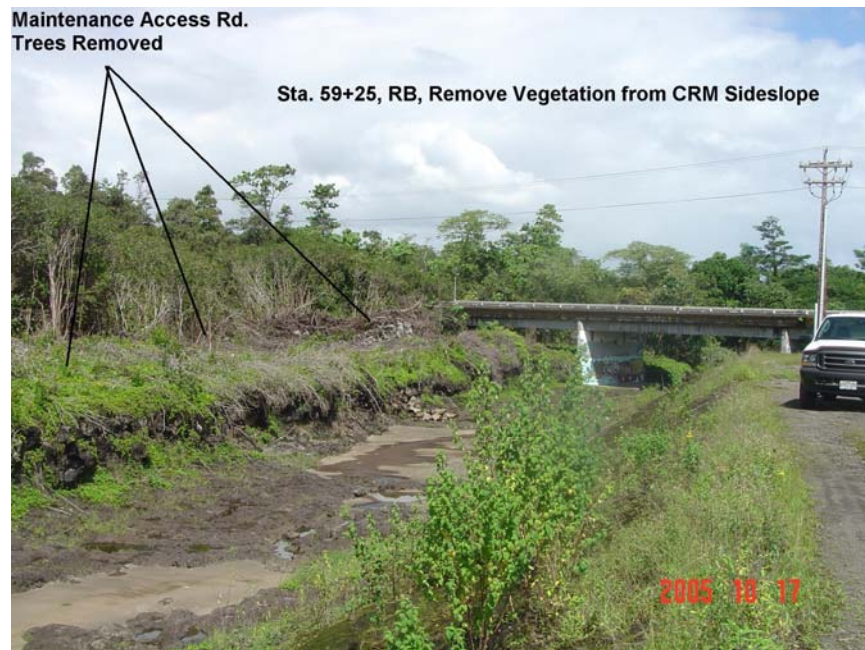
f. Sta. 59+24, Right Bank (RB), Looking Downstream at Levee #3, continue to herbicide vegetation growing on sideslope.

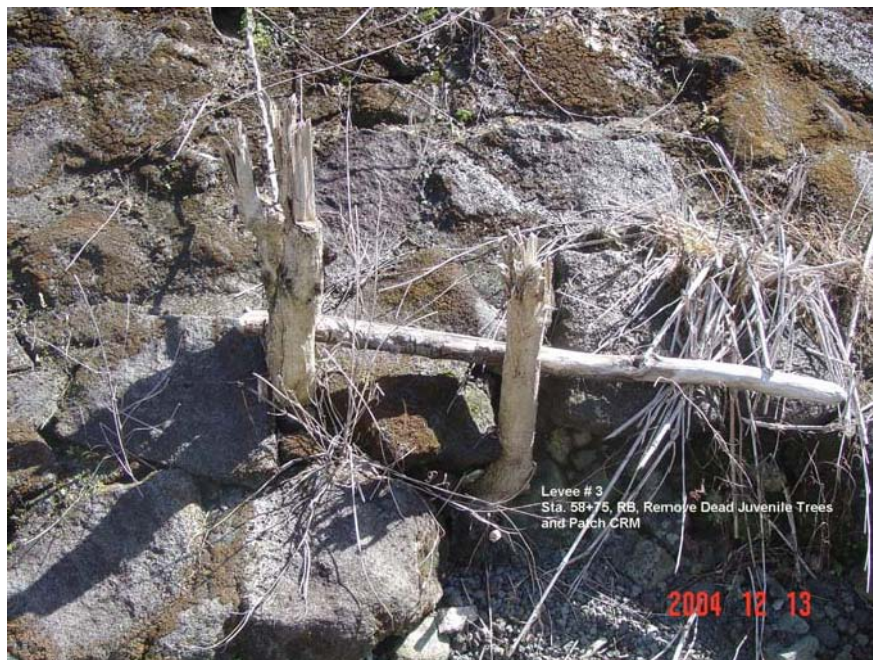
g. Sta. 58+75, RB, Looking Downstream, Levee #3, remove dead trees and patch CRM.

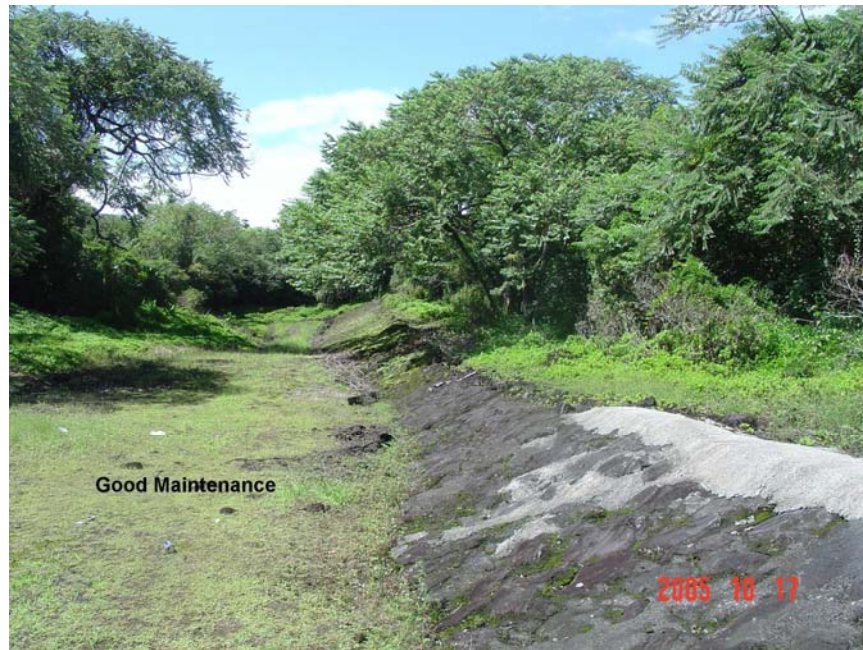
h. Sta. 50+00, Looking Downstream at Levee #4, continue to herbicide vegetation growing on CRM, good maintenance.

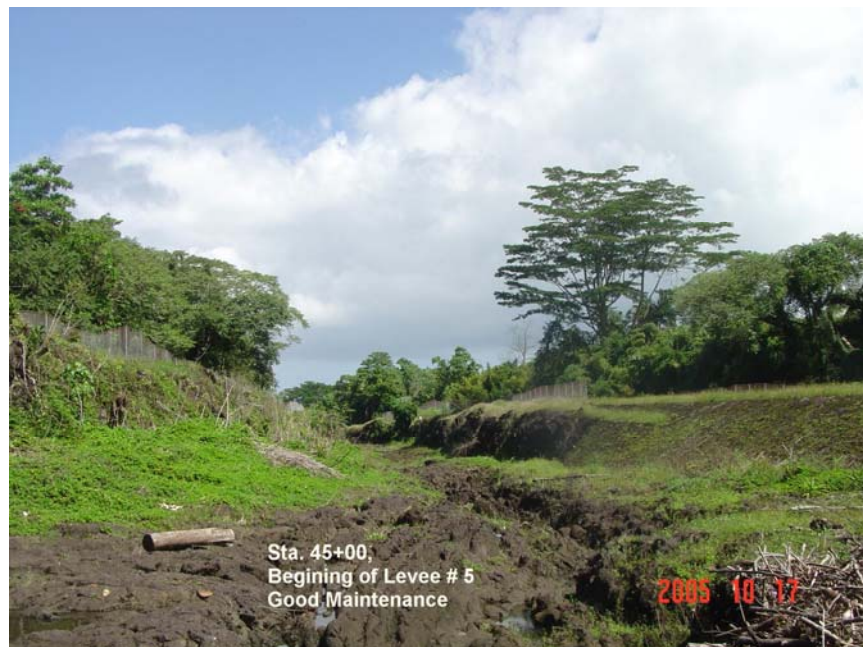
i. Sta. 45+00, Centerline, Looking Downstream on Levee #5.

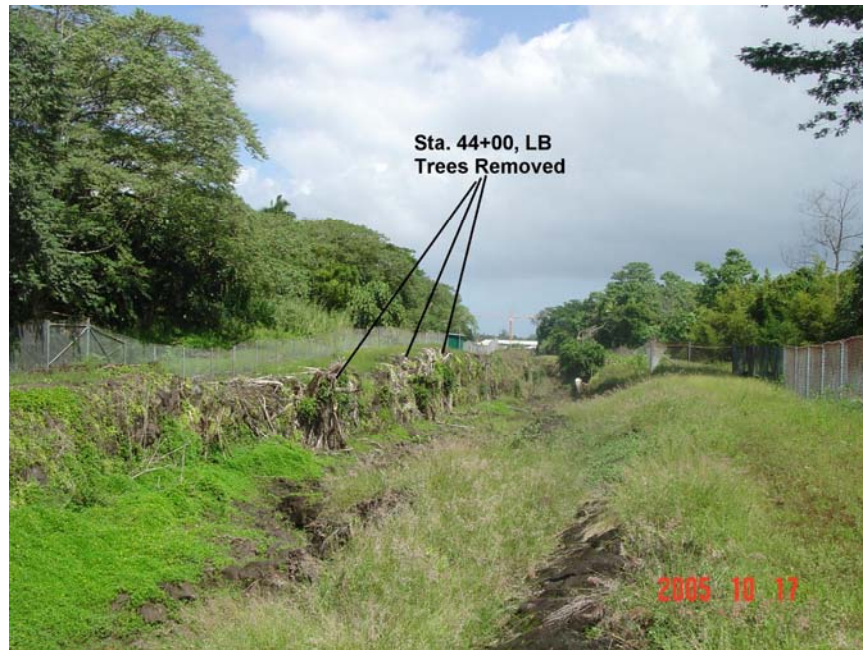
j. Sta. 44+00, Overview, excellent maintenance.

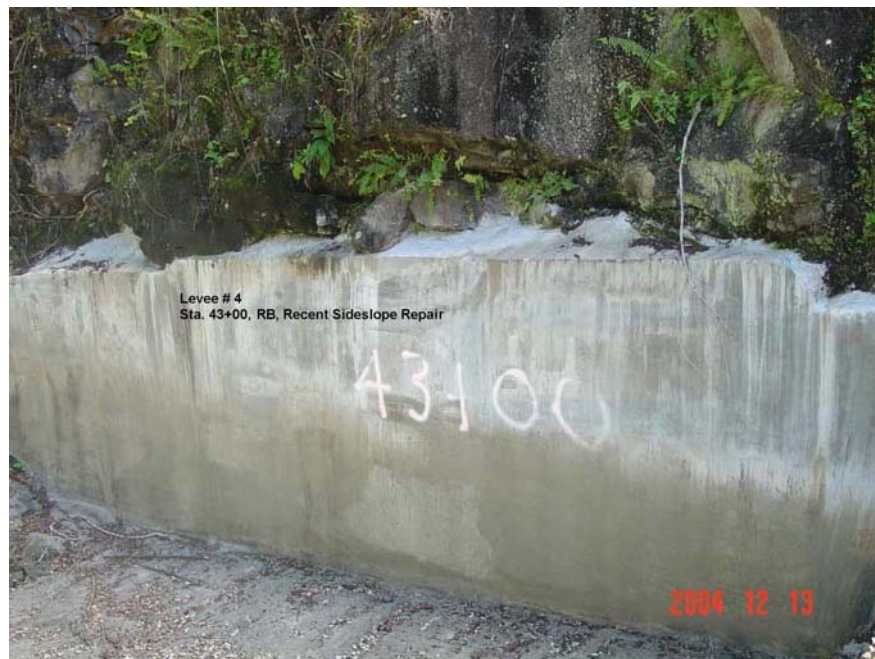
k. Sta. 43+00, Left Bank (LB), 2004 repairs.

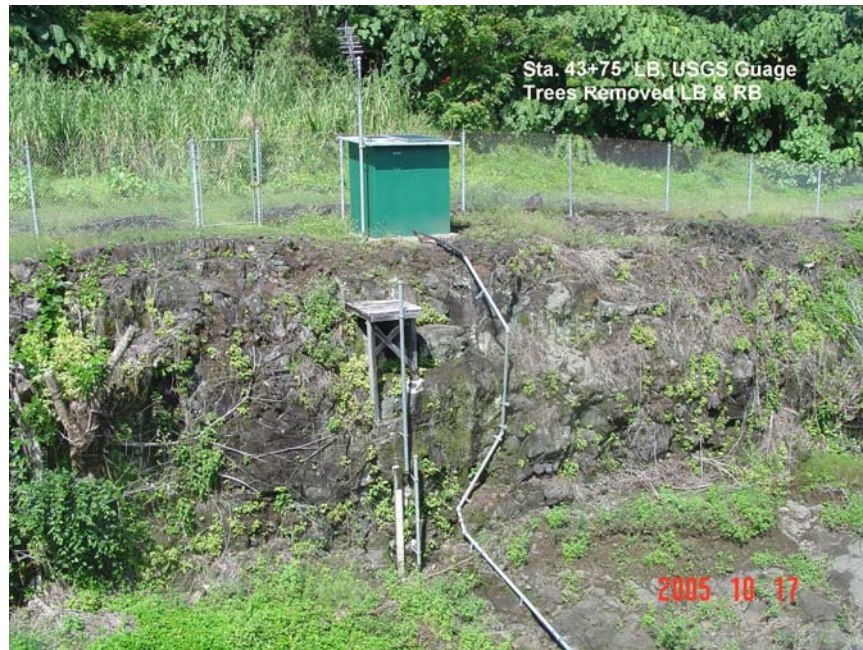
- l. Sta. 43+75, RB, overhanging trees from sideslope have been removed. (LB, USGS Stream Gauge).

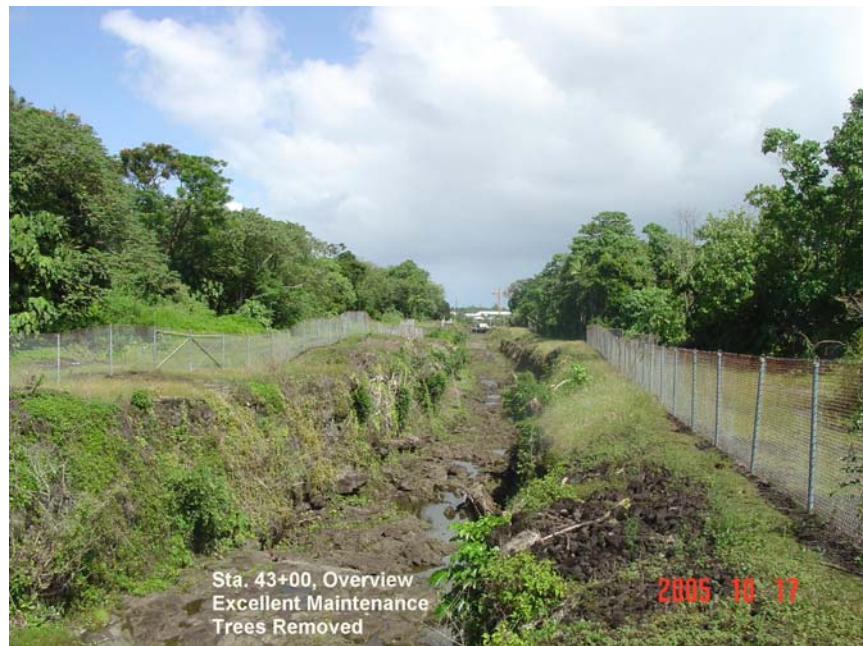
- m. Sta. 43+00 LB, Looking Downstream, trees removed, excellent maintenance.

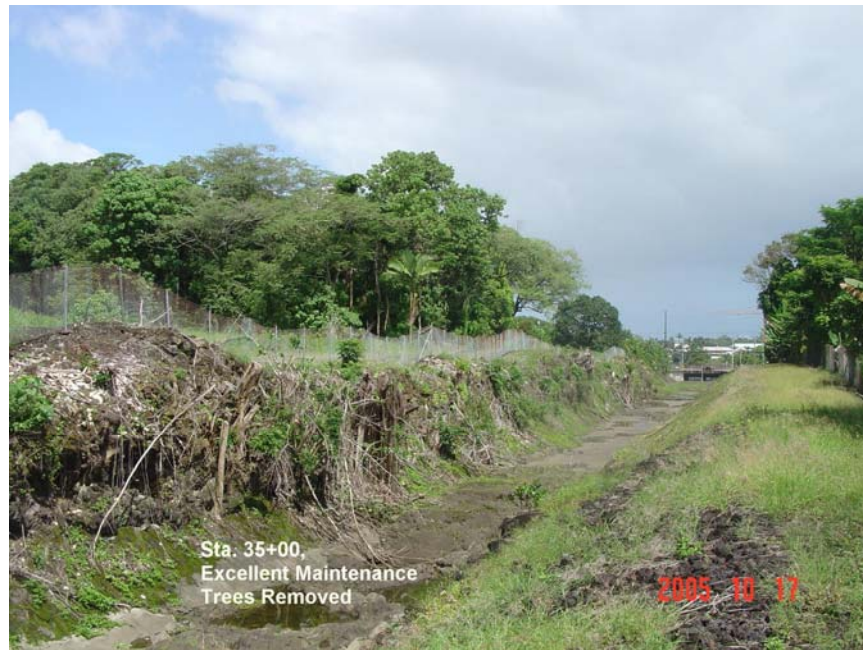
- n. Sta. 35+00, Left Bank, trees removed & maintenance access restored.

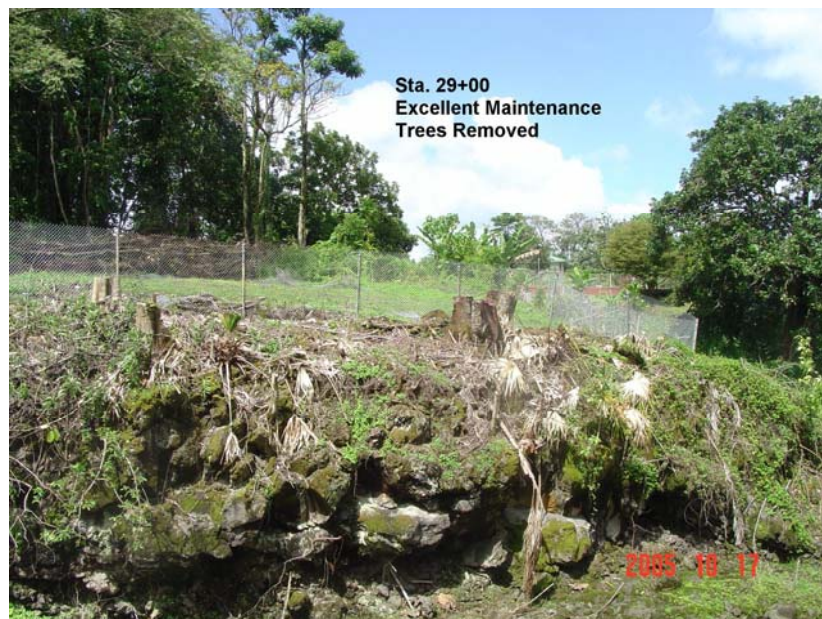
- o. Sta. 29+00, LB. trees cut on maintenance access road and sideslope.

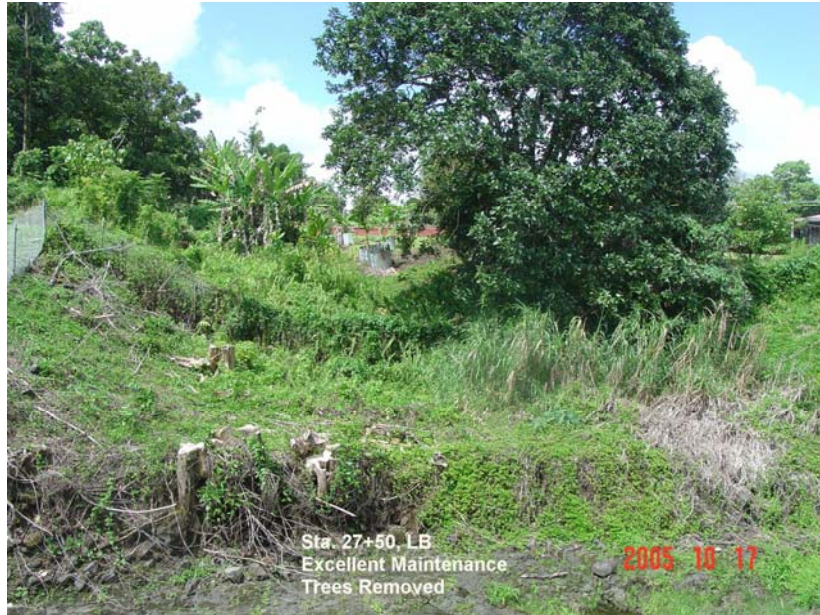
p. Sta. 27+50, LB, trees removed.

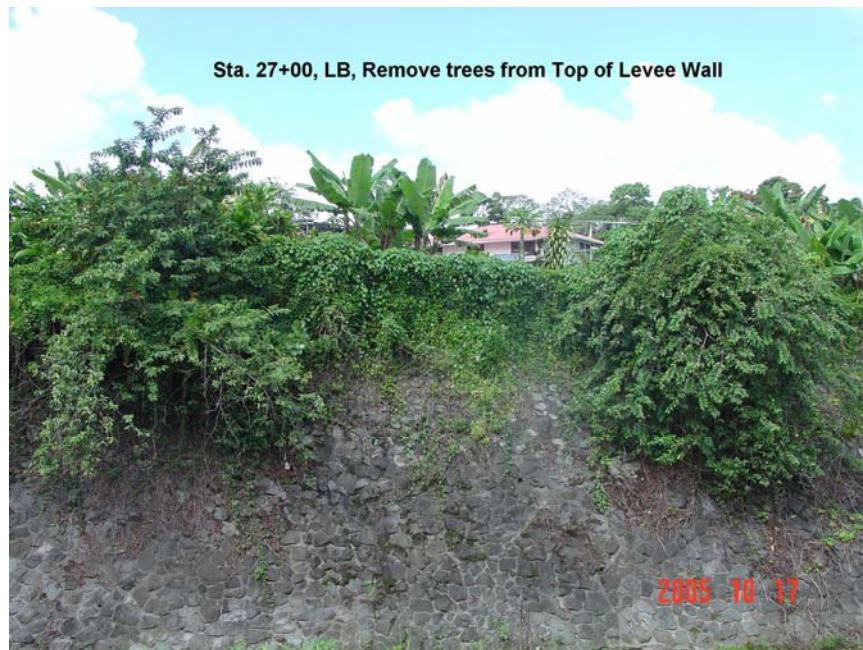
q. Sta. 27+00, LB, herbicide and remove vegetation, unable to inspect sideslope.

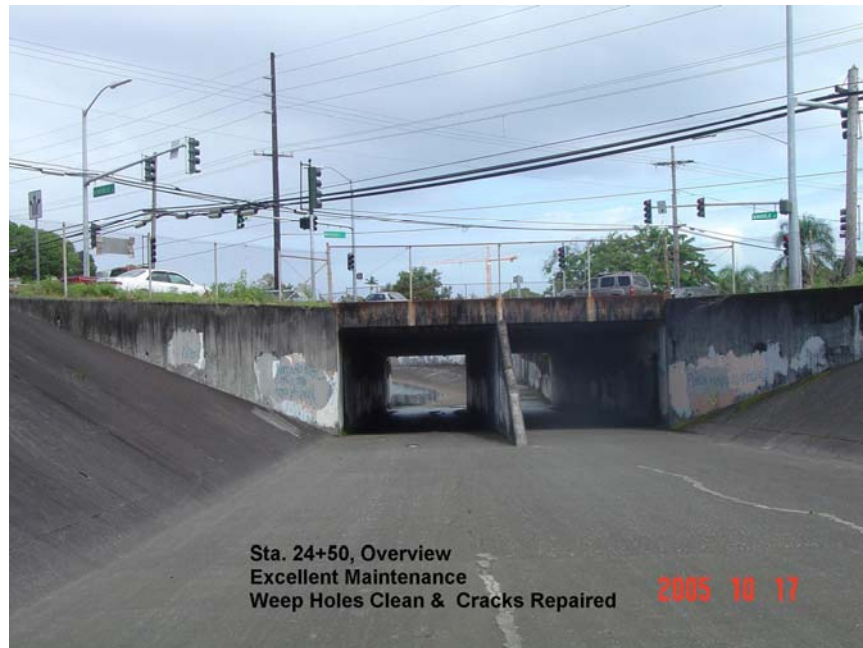
r. Sta. 24+50, Above Kinoole Street Bridge, cracking invert repaired.

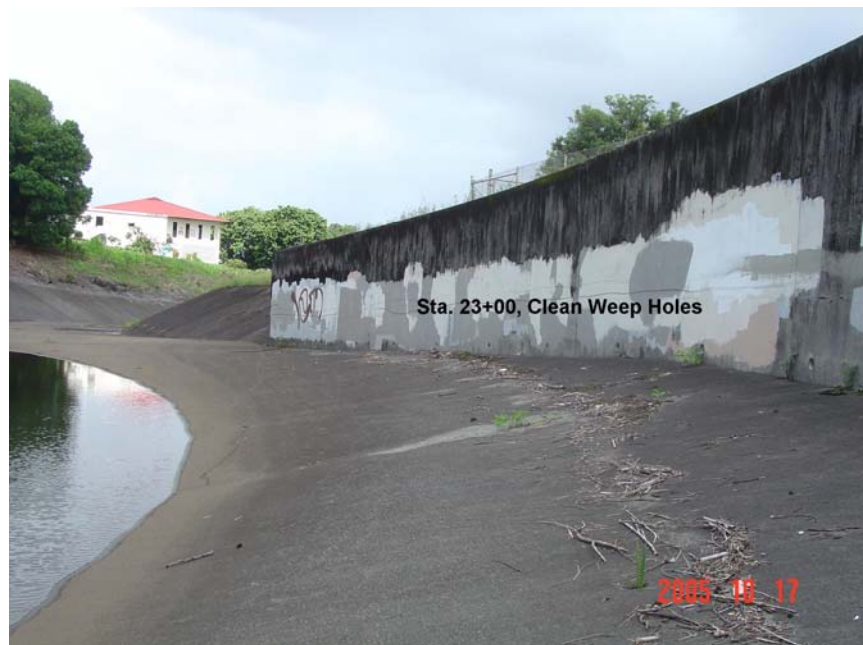
s. Sta. 23+00, Invert, Clean weep holes and construction joints.

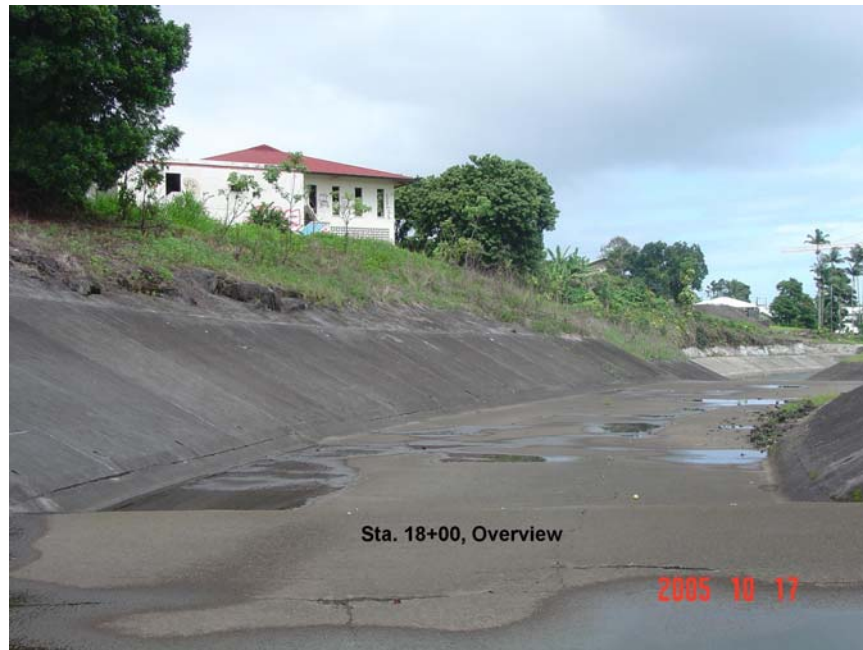
t. Sta. 18+00, Overview, Looking Downstream of Kinoole Street Bridge, herbicide and remove vegetation from sideslope and weep holes.

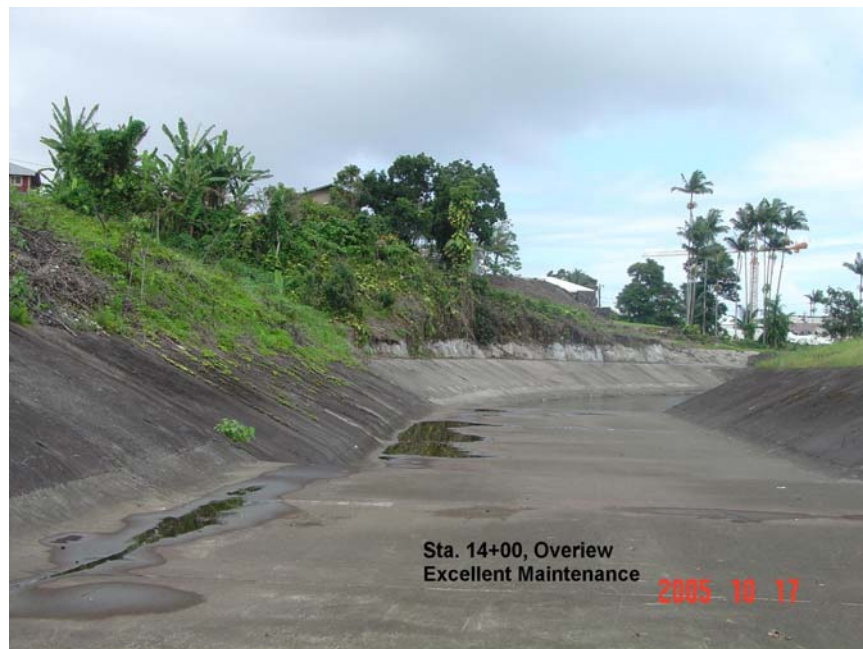
u. Sta. 14+00, overview of recent repairs.

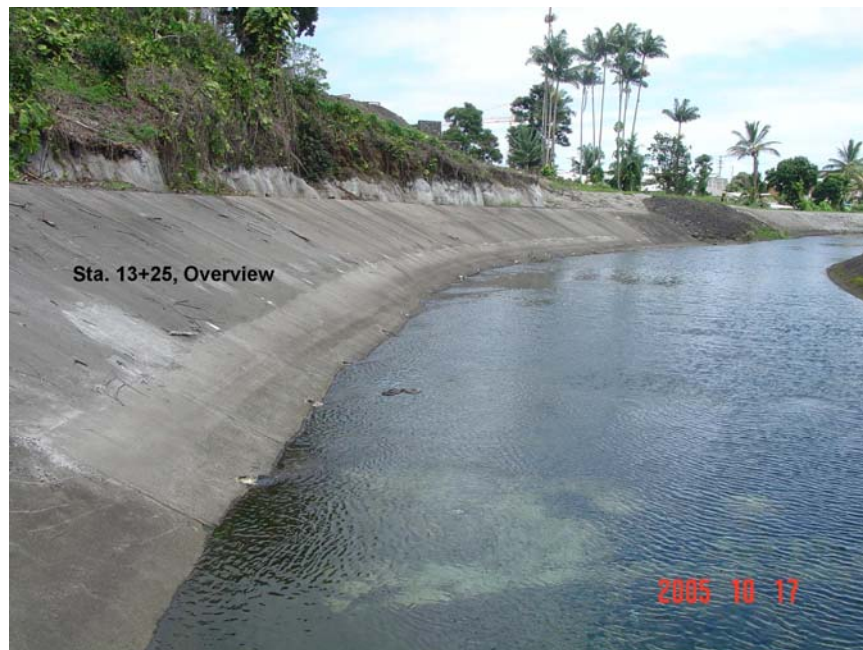
v. Sta. 13+25, LB, eroding concrete adjacent weep holes noted last inspection, monitor.

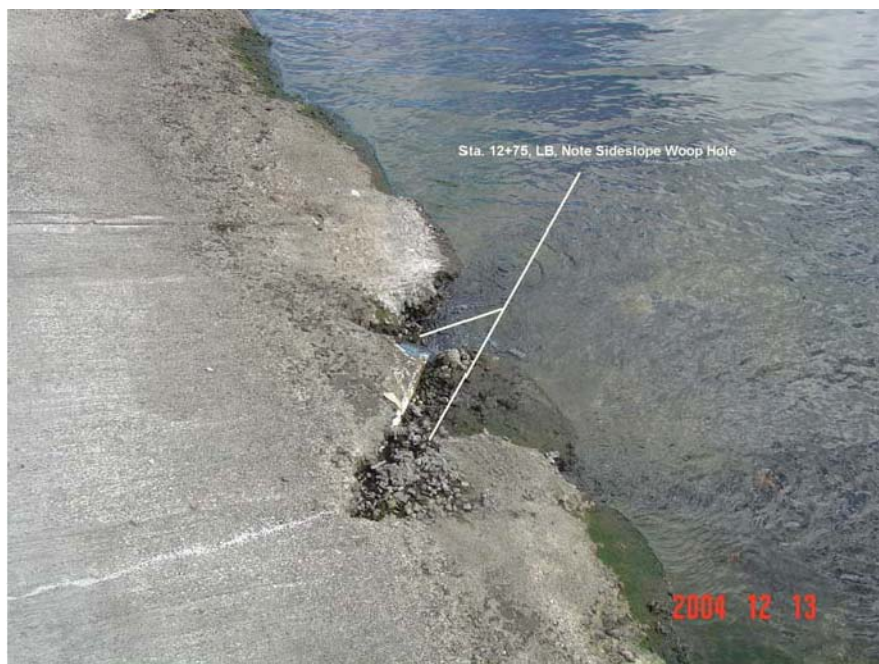
w. Sta. 12+75, LB, Note eroding concrete adjacent weep holes, 2004 photo.

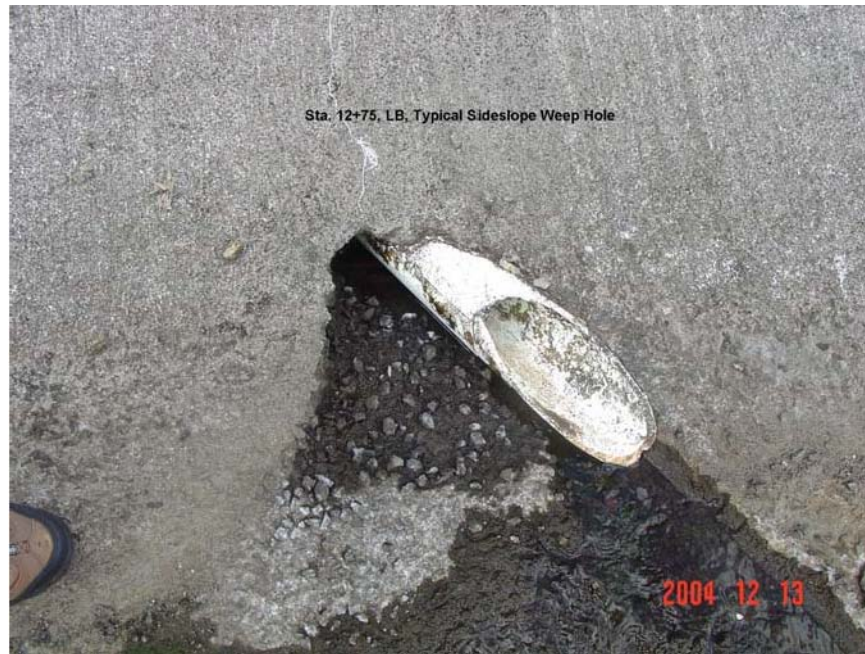
x. Sta. 12+75, LB, Note eroding concrete adjacent weep holes, 2004 photo.

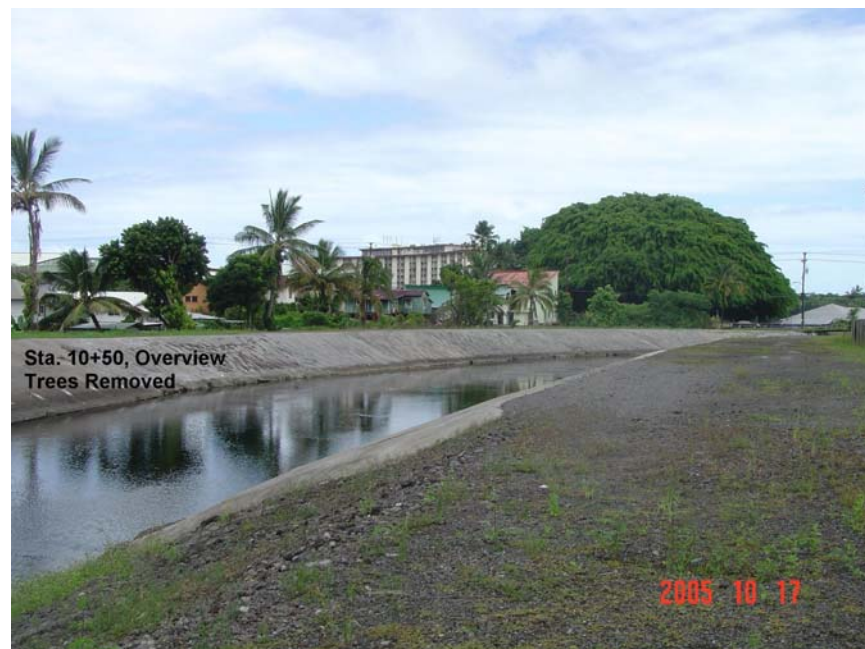
z. Sta. 10+50 to Sta. 6+00, LB & RB, overview of recent repairs.

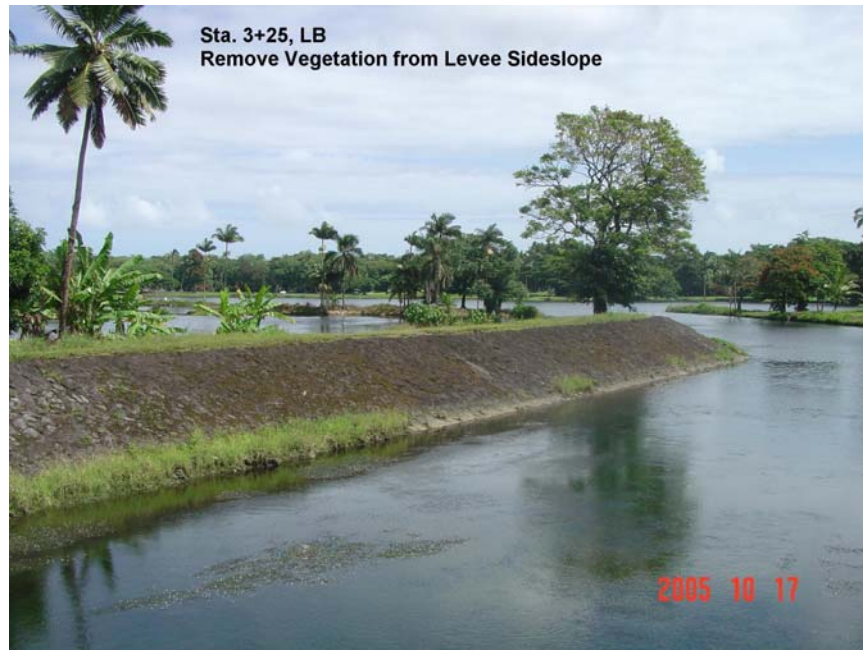
aa. Sta. 3+25, LB, remove tree from townside of levee.
